## SEISMOTECTONIC DANGER FOR THREE CULTURAL MONUMENTS IN SOFIA CITY (BULGARIA)

**Key words:** Sofia graben, active faults and blocks, seismicity, cultural monuments

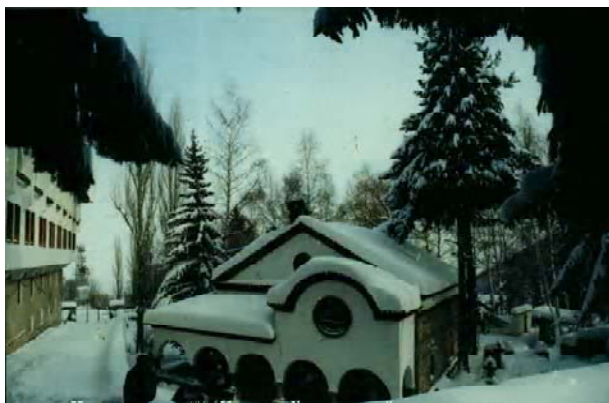
Fig. 2. Dragalevtsi monastery

The Dragalevtsi monastery (14<sup>th</sup> century) was built in the southern periphery of Sofia graben. It was placed on a high and significantly inclined slope of the Vitosha Mt. Horst. The monastery is near the crossing of the Chepintsi and the Vitosha faults, also near the seismically activated fragment of the Vitosha fault zone during the 1858 Sofia earthquake (Fig. 1). It had an important role for the culture, the education and the liberation of the country. The monastery (Fig. 2) is among the national cultural heritage from the Second Bulgarian Kingdom (1187-1396). The Dragalevtsi monastery was reconstructed after the 1917 Sofia earthquakes.

The Dragalevtsi (Fig. 2), Kremikovtsi (Fig. 3) and Seslavtsi (Fig. 4) monasteries were built or reconstructed several times during the periods before, during and after the Ottoman domination. Their foundation was related mainly to the increase of the economic potential and the natural culture of the population in Sofia region. A lot of data for the reconstructions of the monasteries have been registered. Various causes provoked the recon-

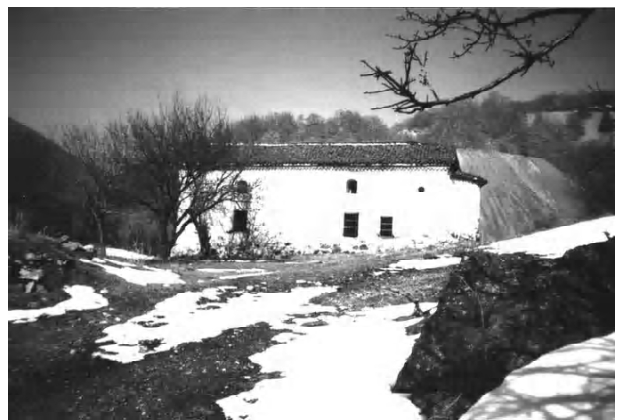
Fig. 4. Seslavtsi monastery

The Seslavtsi monastery (17<sup>th</sup> century) is located in the lower part of the considerably inclined southern slope of the Balkan Mt. It is again in the northern periphery of Sofia graben, more correctly in the contact zone of the graben with the adjacent horsts. The monastery is in close vicinity to the crossing of the Chepintsi, Negushevo and Elin Pelin faults (Fig. 1). The monastery (Fig. 4) is a heritage from the period of the Ottoman domination (1396-1878). The construction of the monastery during the 17<sup>th</sup> century shows the high increase of the economic potential and the cultural interest of the population of Seslavtsi Village and Sofia region (Prashkov et al., 1992). The Seslavtsi monastery was reconstructed after the Sofia earthquakes of 1818 and 1858.
