Modern debris flow activity in southern slopes of Rila Mountain, with an example from the area of Cherna Mesta village

Zornitsa Dotseva, Ianko Gerdjikov, Dian Vangelov
Зорница Доцева, Янко Герджиков, Диан Вангелов

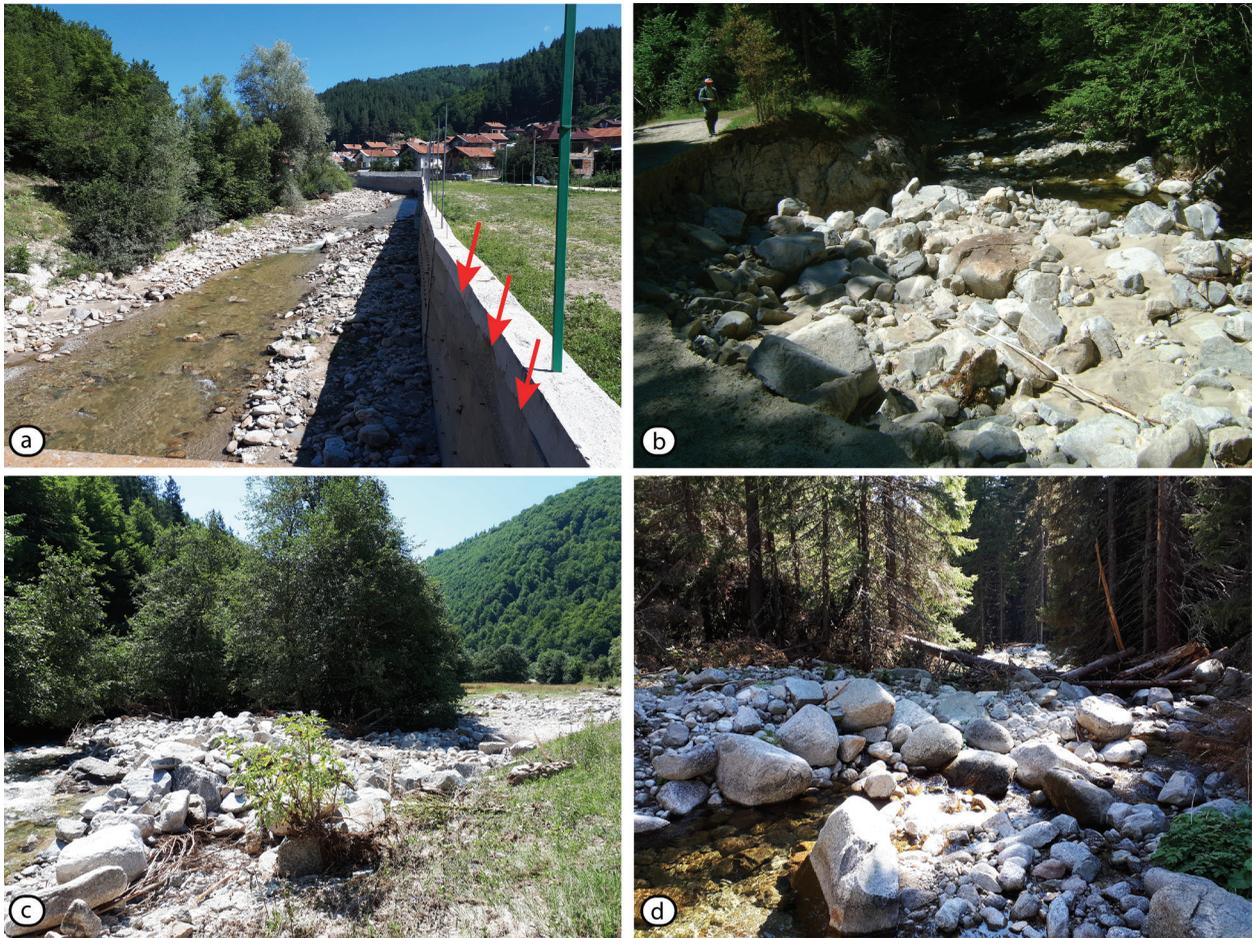
Fig. 1. *a*, very poorly-sorted debris flow deposits in the Cherna Mesta River channel near Cherna Mesta village. Red arrows shows the flood level from last event; *b*, unsorted debris flow deposits with boulder size in Sofan Dere River, before the confluence with Dautitsa River; *c*, river dam and levee formed by debris flow deposits; *d*, river channel from upper part of the Cherna Mesta watershed filled with loose gravel to boulder size sediments and organic material

In the lower parts of the watershed alluvial sediments consist of unsorted to poorly sorted sand, gravel and boulders formed lateral levees on the river banks or in the stream channels and were typical for debris flow deposits (Fig. 1a, b). In the middle parts of the watershed slopes are steep but in some places were formed recent sediment accumulations (levees and dams – where the slope is shallower). They act like a trap for the material with different size and these unconsolidated sediments could be mobilized in the debris flows in case of extreme rainfall (Fig. 1c). In the upper parts of the watershed river channels incised in the basement and were filled with loose debris material (mainly Quaternary glacial sediments and organic) which acts like a main source of sediment supply for the debris flows (Fig. 1d).
